Record Name: Clapper Bridge
SWAAG ID Number: 440
Recorded Date: 2012-01-28 17:13:50
Recorded by: Stephen Eastmead
Category: Stone structure
Record Type: Archaeology
Site Access: Army Range
Record Date: 2012-01-28
Location: Bellerby Moor
Civil Parish: Bellerby
British National Grid: SE 09179 93140
Altitude: 294m

Description: Stone Clapper Bridge constructed over a small beck. The track leading to the bridge connects the Preston Moor coal pits with the main road towards Leyburn, North Yorkshire. In addition the area is rich in pre-historic archaeology including adjacent Burnt Mounds, cairns, a possible burial mound and a nearby barrow.

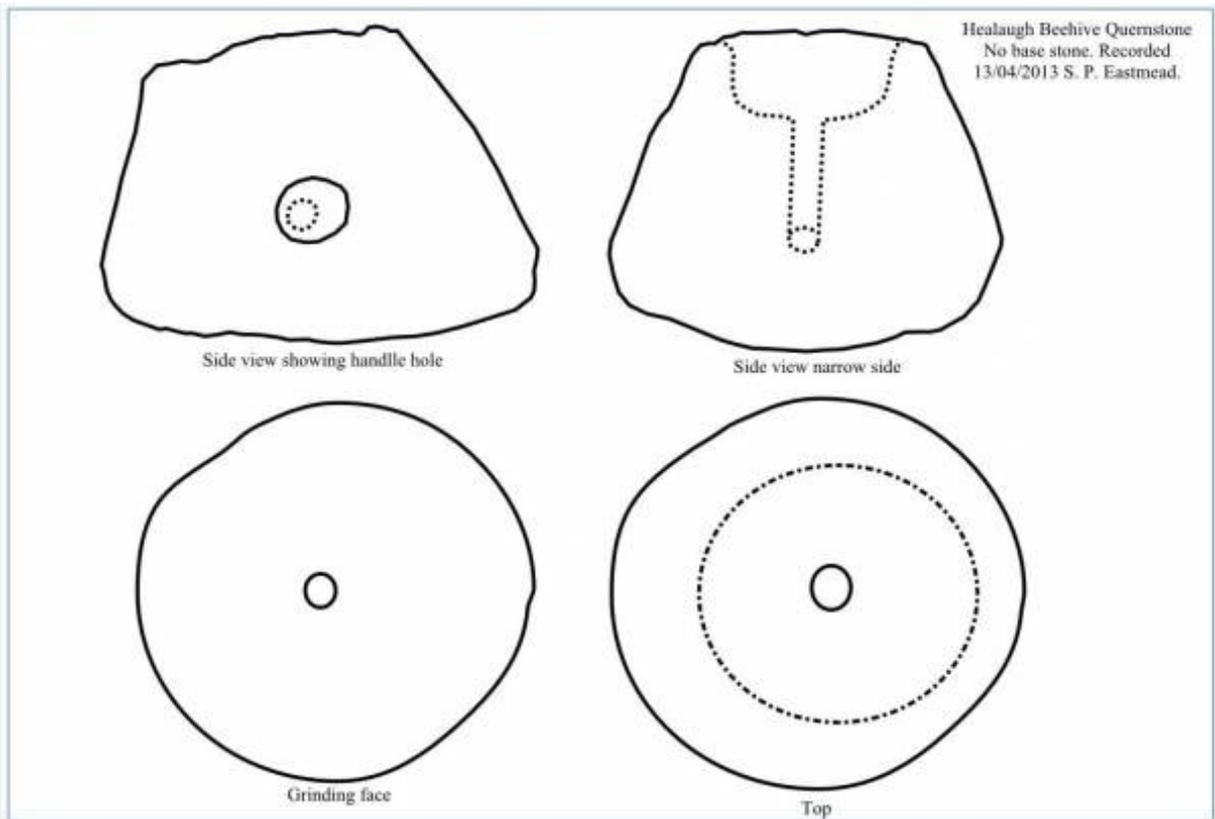
Record Number 716 >>> Image 1: Drawing of a top stone of a Beehive quern found in Healough.

The quernstone has a lop-sided asymmetrical shape similar to a horses hoof see image 10. There is a single hole for a handle which is conical in shape. The hopper is relatively large. It is made from a coarse millstone grit containing no crinoids or other fossils, but occasional pebbles up to 1cm.

Diameter: Ovoid 300mm - 330mm. Height varies between 160mm - 190mm. Hopper and Feed pipe are both off-centre. Hopper width ovoid 140mm - 150mm. Hopper Depth 60mm. Diameter of feed pipe 23mm. Handle hole ovoid and conical 30mm - 35mm diameter and 75mm deep. approx. The handle hole does not piece the feed pipe. The feed pipe gives the impression that it was mainly drill from the top, but later drilled from the bottom to complete the feed pipe.

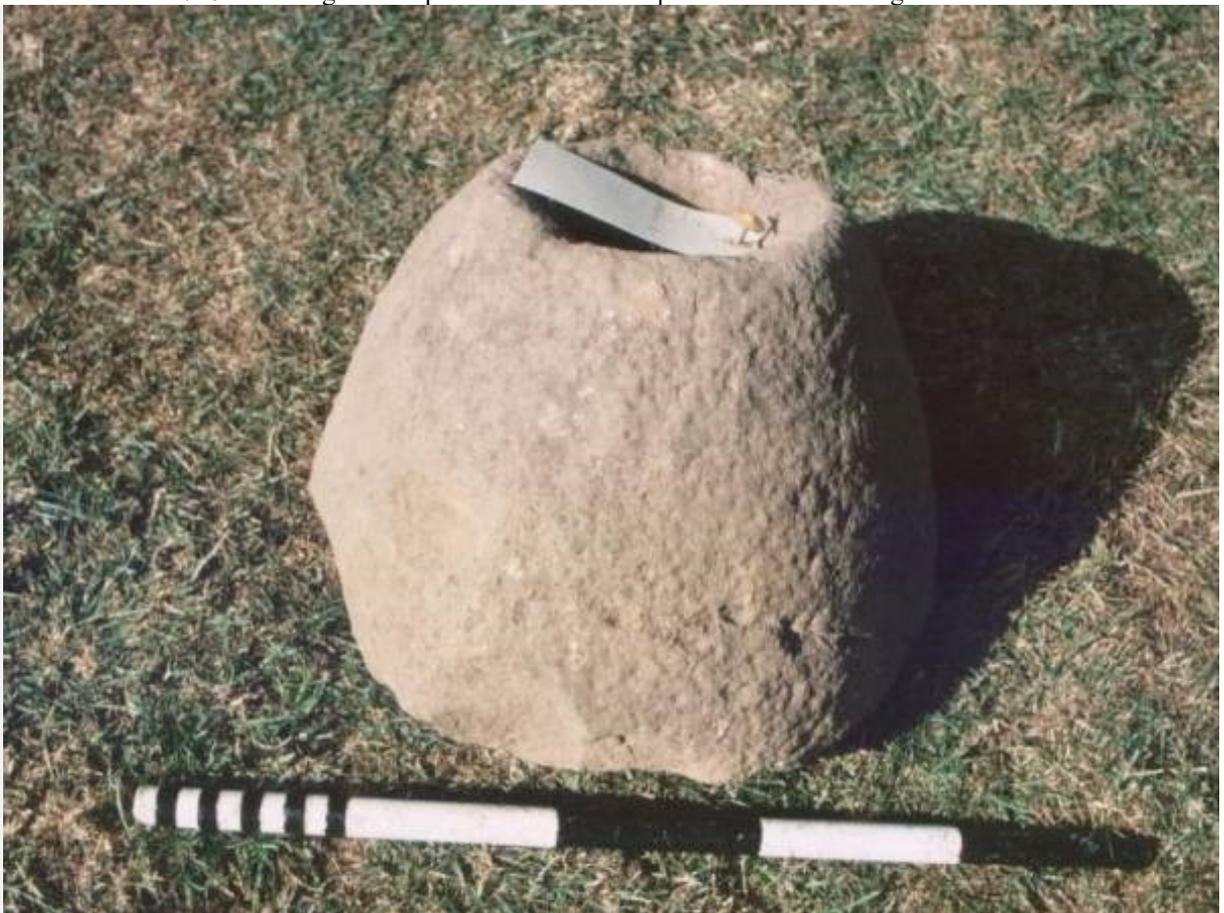
Record Number 716 >>> Image 12: Quern found during the 1988-90 excavation at Healaugh.

Image 12 shows the larger quern found at the Healaugh excavation 1988-90.

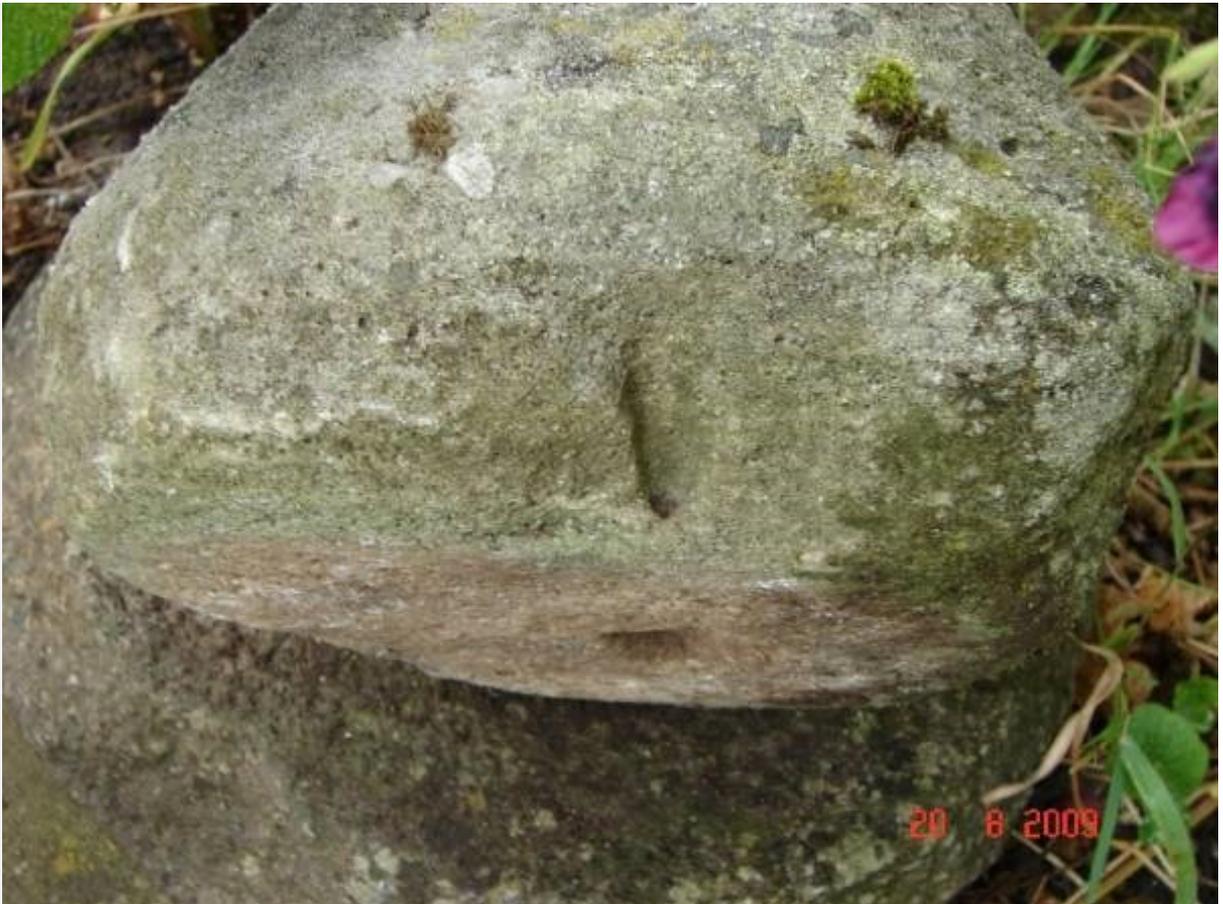
Record Number 716 >>> Image 16: Quernstone found on Hagg Farm Fremington. Note shallow handle hole.

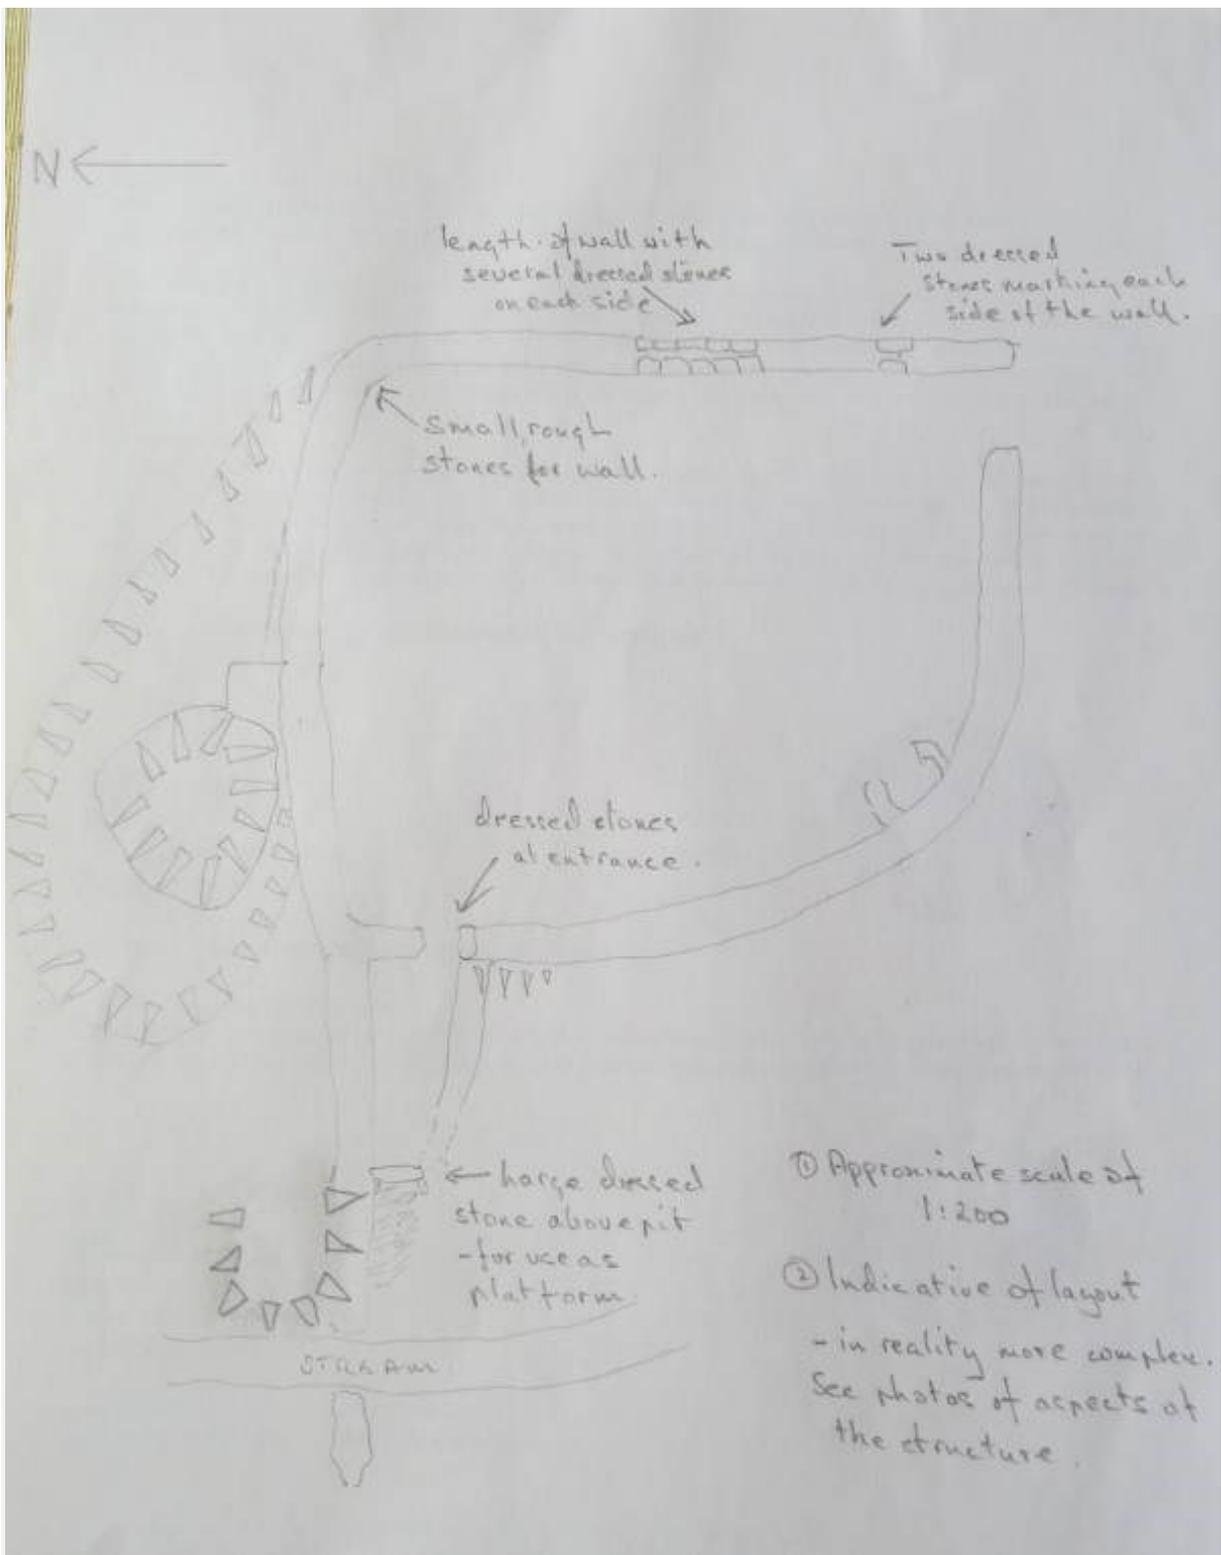
Record Number 823 >>> Image 1: Drawing to indicate the shape and relationships within the whole site, but accuracy is not its strong point.

Description: A large irregular sheepfold whose walls are now largely collapsed, but show significant differences in construction with large regular, worked stones in places as against rough, gathered, small stones elsewhere, suggesting many years use with occasional repairs. The walls have rounded corners and funnel towards the western side with a smaller gathering area built on to the main wall. The gathering area then narrows still further and leaves the fold with the main wall to the North and much less left of one to the South. This small area converges on a large flat stone above a pit which close inspection reveals to at least partially to have been lined with regular, worked stones. The wall to the North continues to become what appears to be the remains of a dam that blocked the small stream (Black Beck) that runs past so as to fill the pool. The dam remains can be seen to continue on the far bank of the beck. The overall purpose would seem to contain gathered sheep and then wash them in a constructed pool. Although the walls follow the contours of the land and allow for such things as a coal pit, the site overall is flat, most of it varying less than a metre in height.

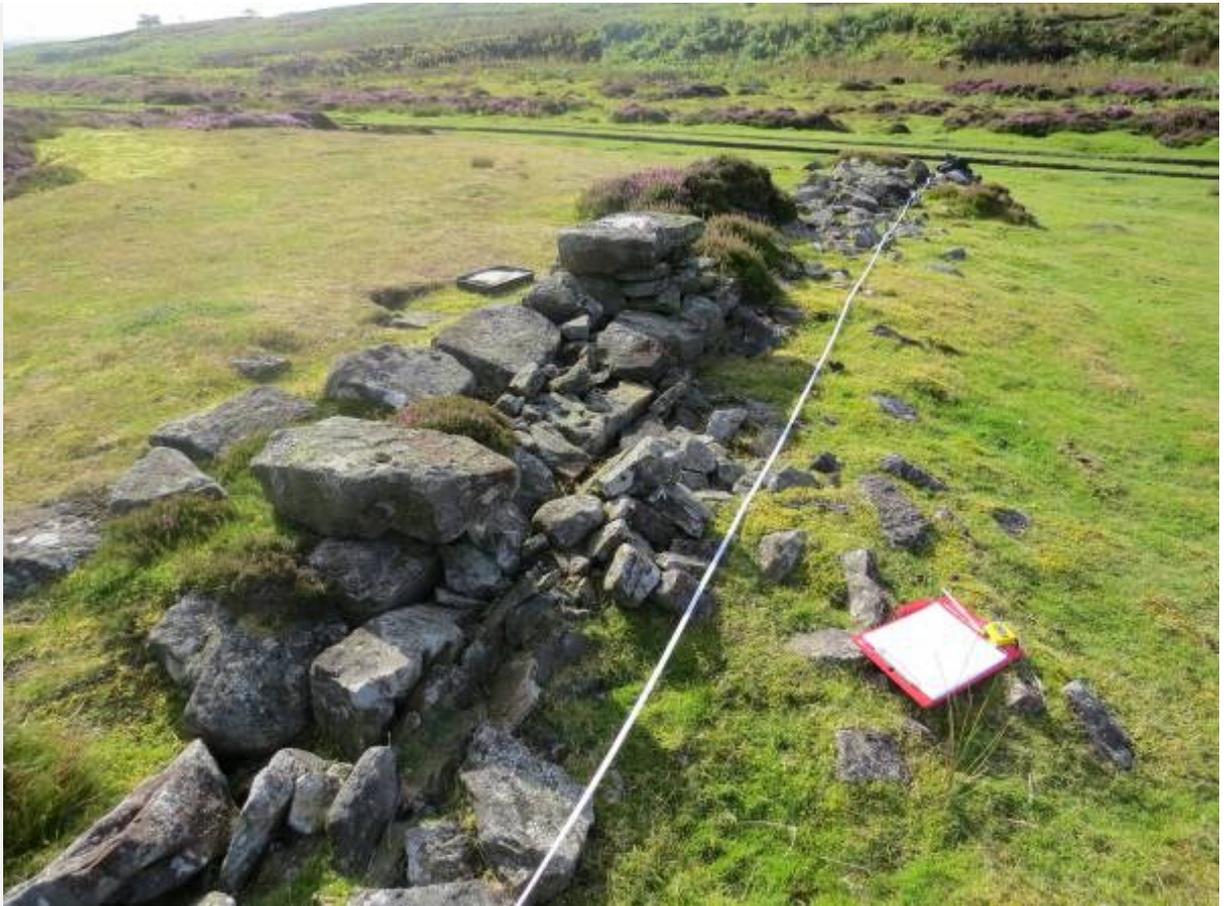
Record Number 823 >>> Image 2: The East wall showing some high-quality stones and the clear wall-line. The East wall is both the straightest and contains the best stone.

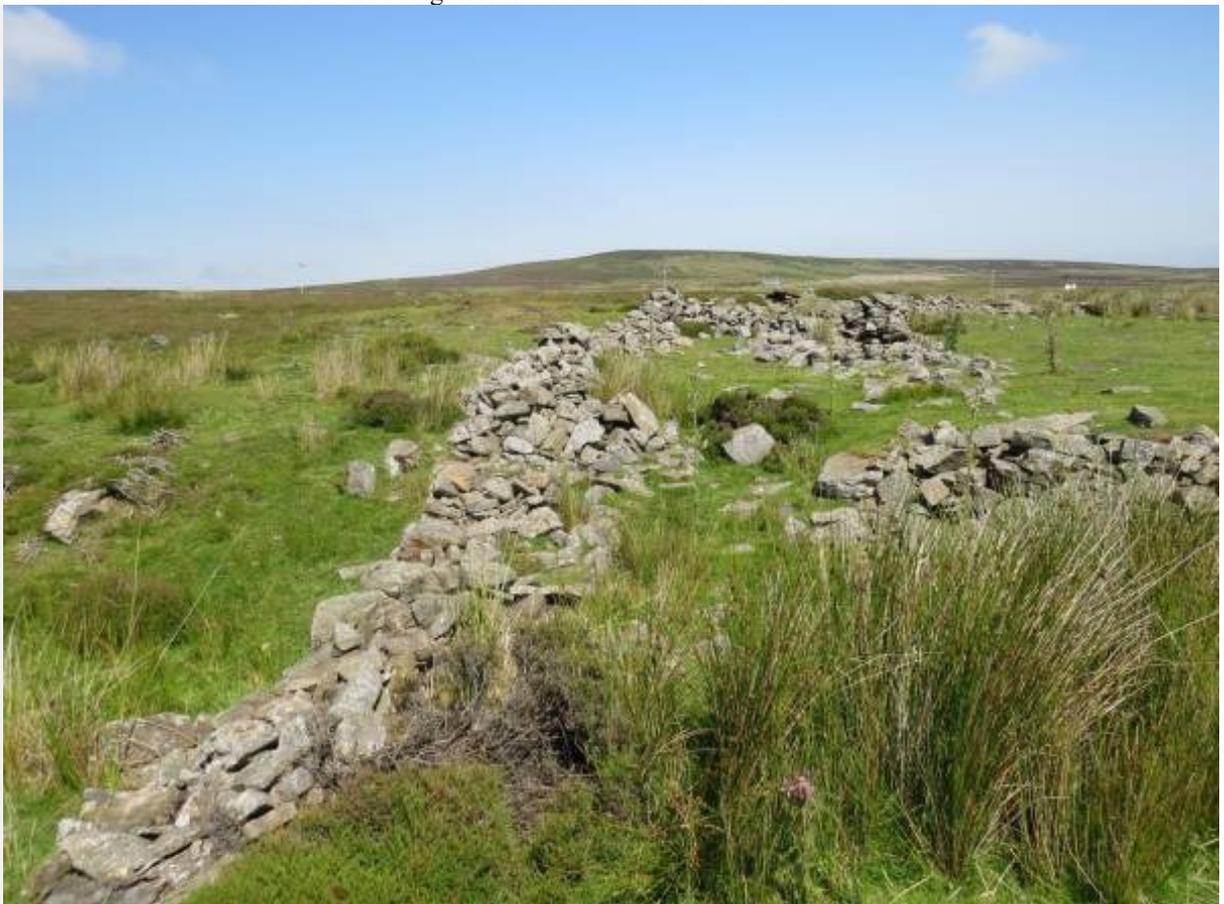
Record Number 823 >>> Image 3: The North Wall from the washing pit back to the NE corner showing the meandering nature of this wall as well as the small internal enclosure where sheep will have been kept

immediately prior to being immersed in the pit of water.

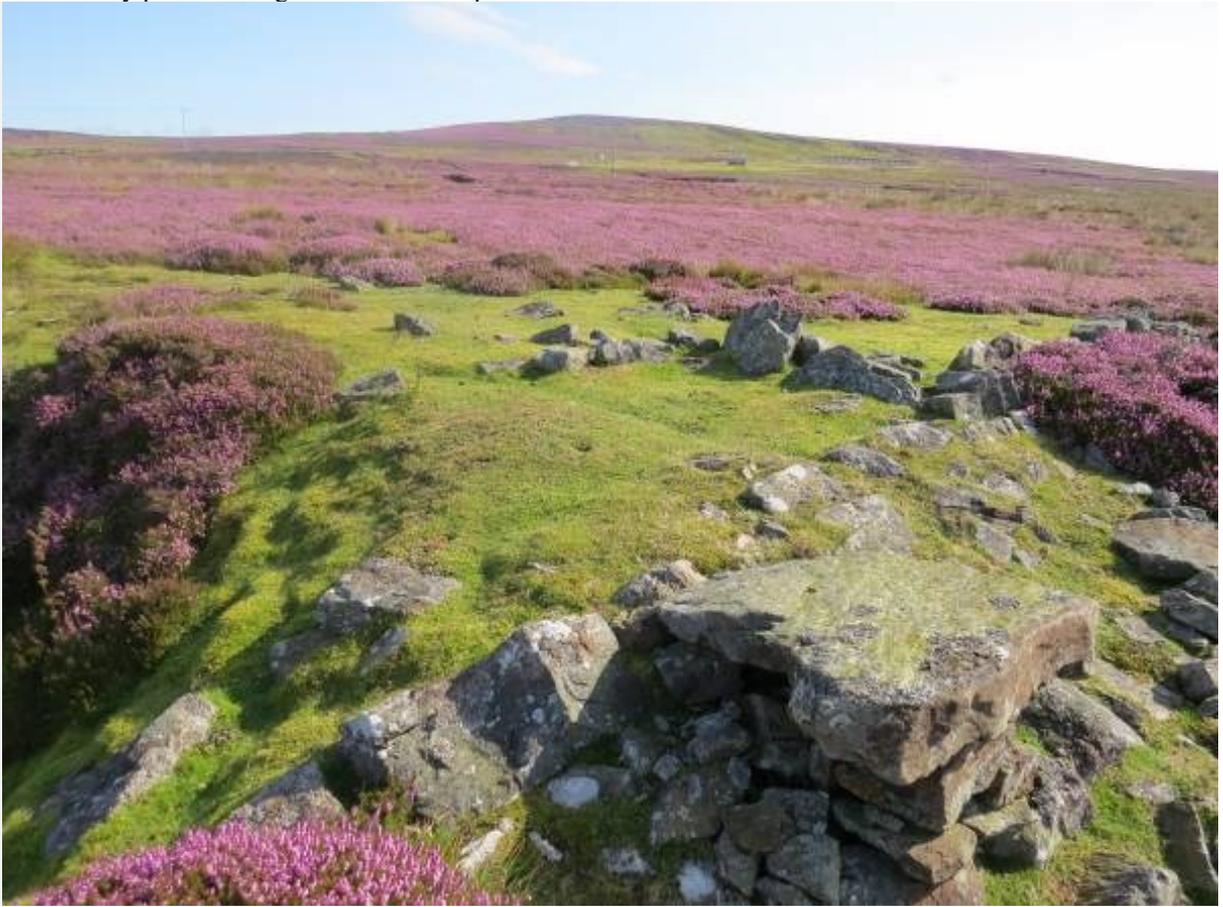
Record Number 823 >>> Image 4: A small external enclosure (1.4m square), one side being the main wall, two having thin, flat stones on their sides (the only place this occurs) and the fourth side being the coal pit. Both this enclosure and the main wall go over the spoil from the pit which is part of a 19th century area of pits (Mines and Miners of Wensleydale by IK Spensley) suggesting the enclosure is no older than that.

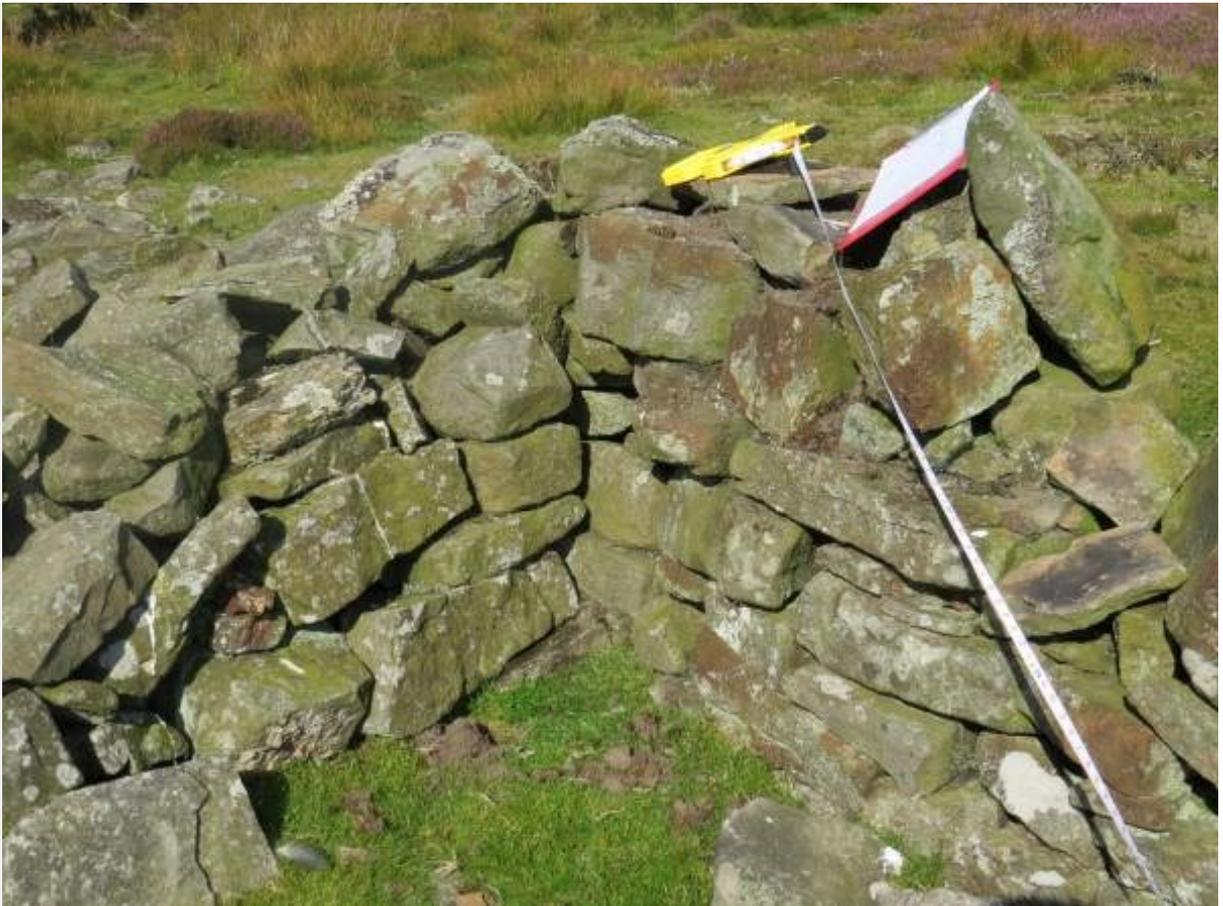
Record Number 823 >>> Image 5: The junction of the main East wall and the internal enclosure showing one of the highest points of the overall enclosure. The internal enclosure is believed to have been used for gathering sheep immediately prior to their being immersed in the pool.

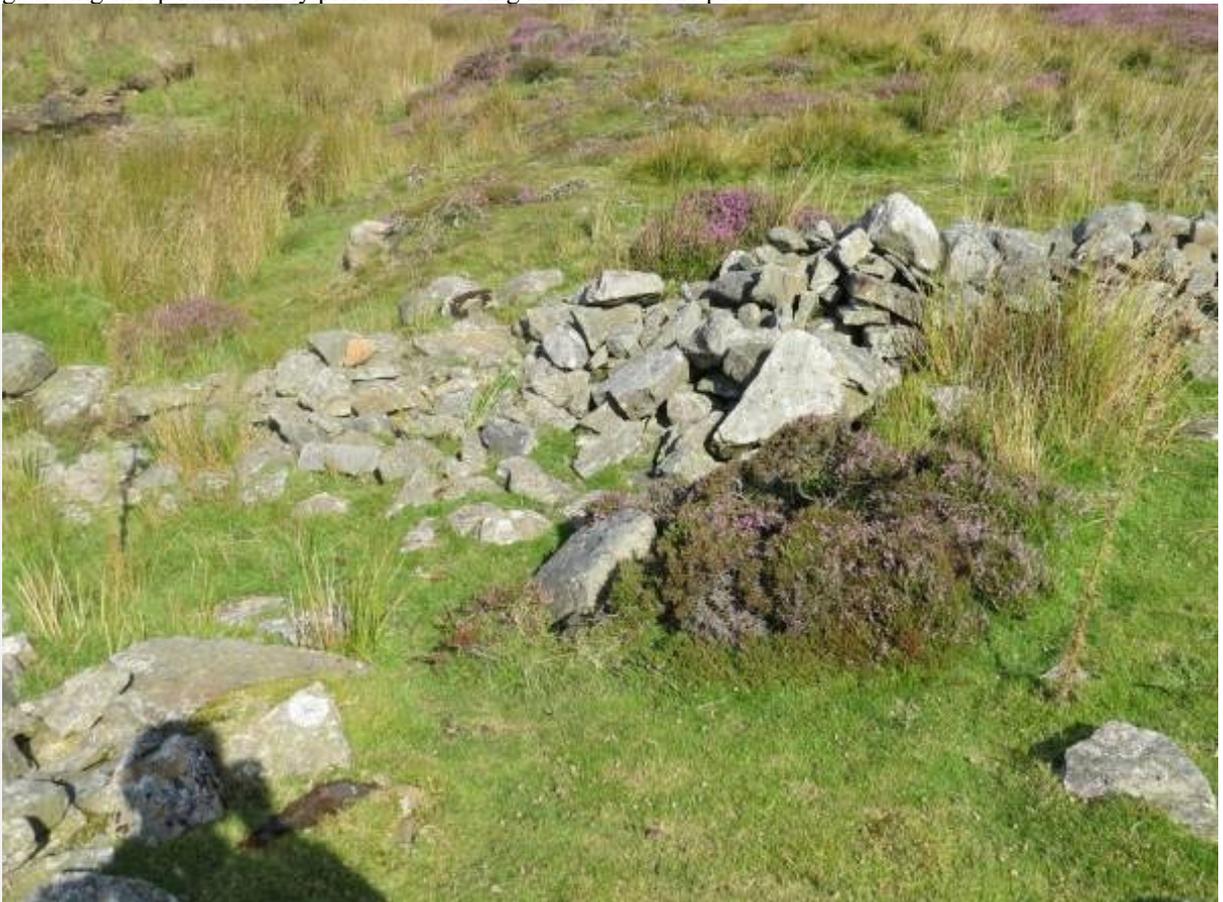
Record Number 823 >>> Image 6: The exit from the internal enclosure. Note the dressed stone on the left

- which sits on another similar one.

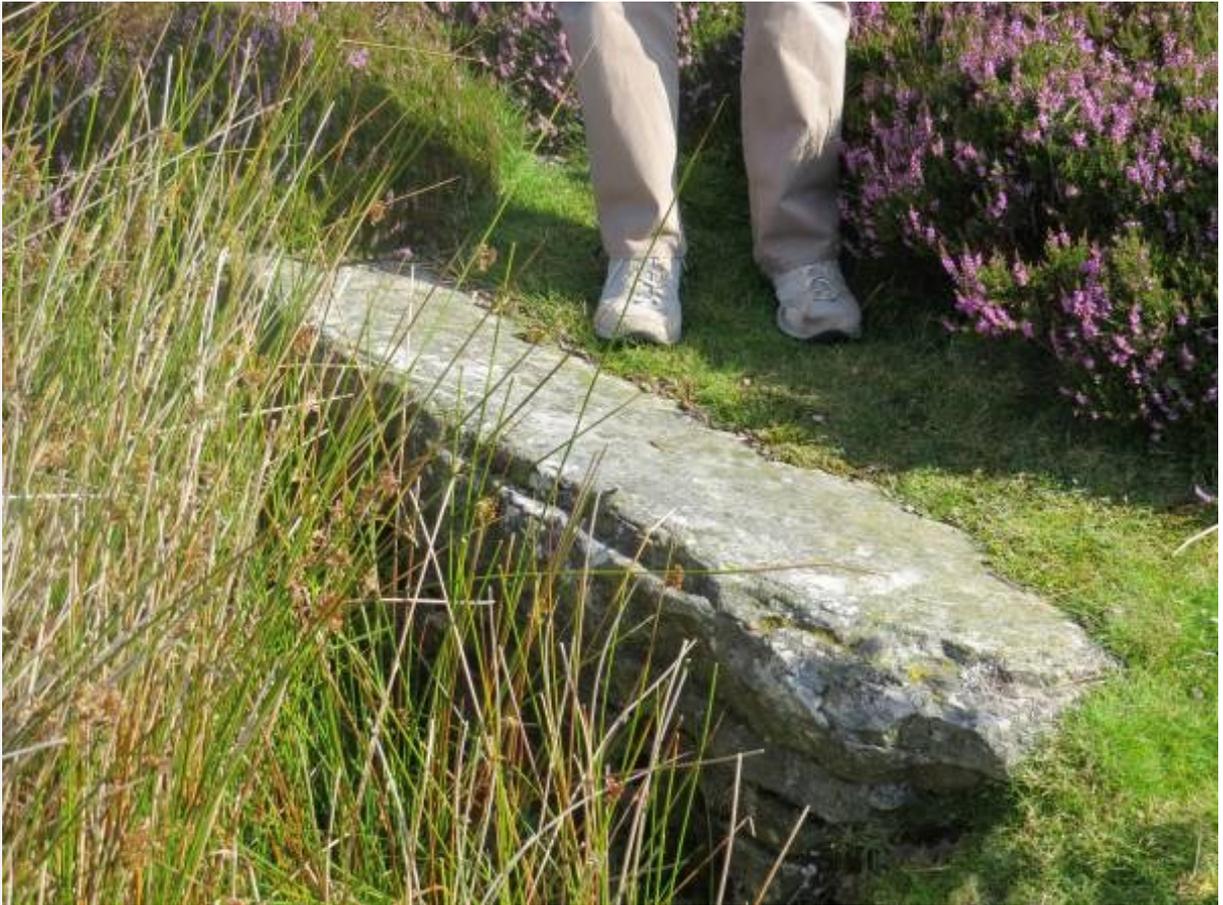
Record Number 823 >>> Image 7: From the internal enclosure it seems the sheep were brought to this large (at least 1.70m x 50cm) flat, dressed stone (SE 07909 93836) which was the platform for pushing the sheep into the pool. The stone sits on a well-built stack and has sides radiating on either side and forming the banks of the pool. The construction would support heavy weights and allow violent activity.

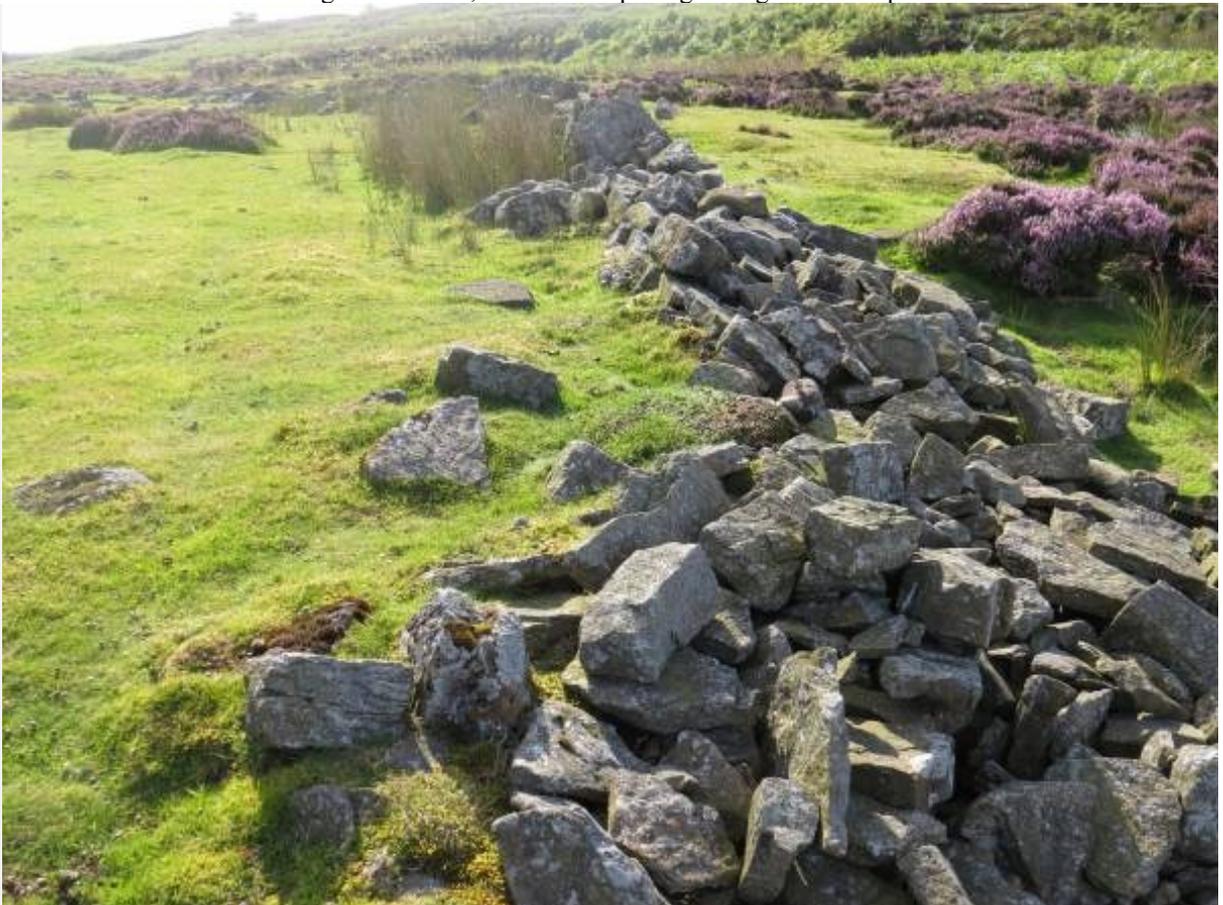
Record Number 823 >>> Image 10: Looking SE from the internal enclosure exit showing the way the wall curves round and there is another small internal circular enclosure at the apex. This wall is both the west and south side of the enclosure and finishes back at the entrance to the enclosure.

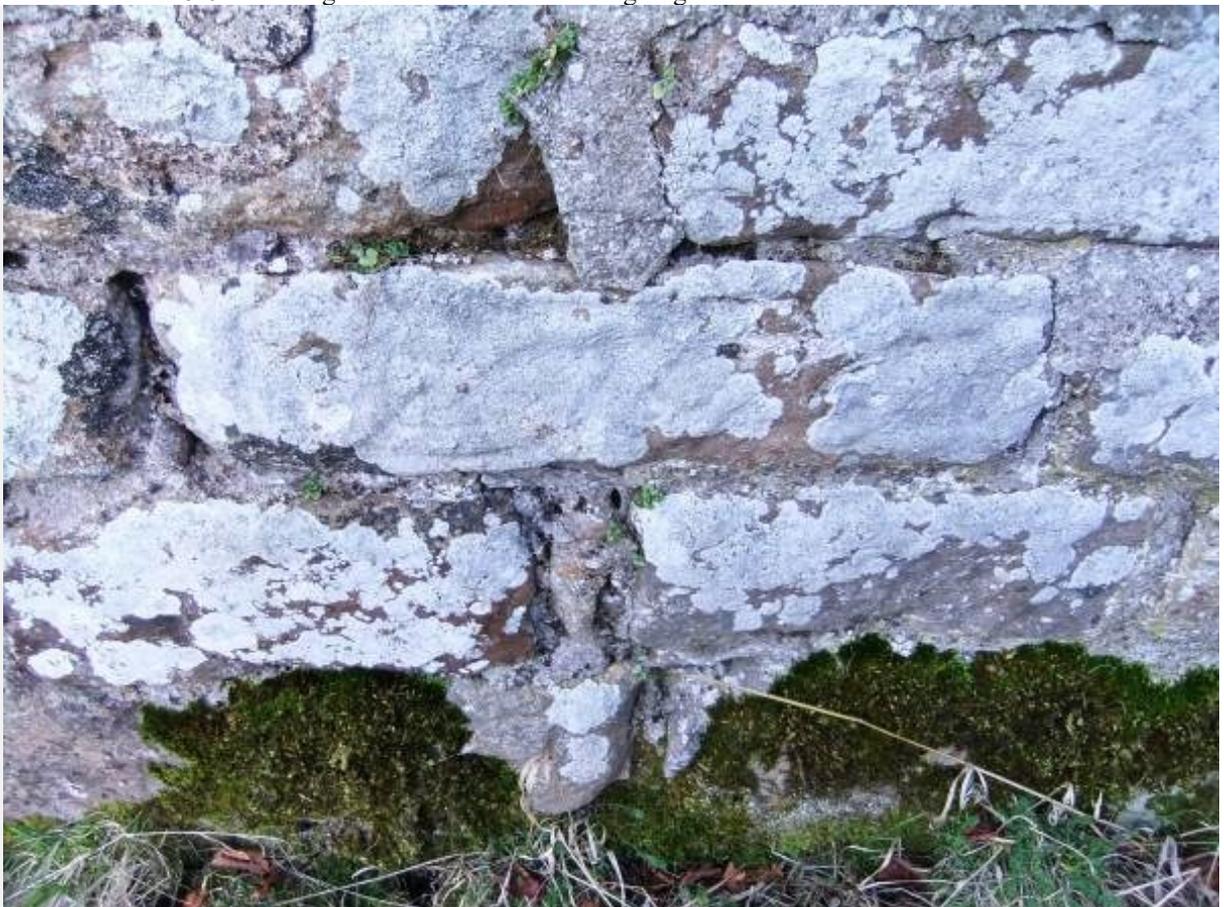
Record Number 845 >>> Image 3: Interlace decorated Ninth C. cross fragment built into the masonry.

10thC and earlier Pre-Conquest Christian activities. The presence of a interlace decorated fragment of a cross shaft built into the North Wall of the Chancel points to the existence of an Early Pre-Conquest Christian Oratory, or similar timber structure.

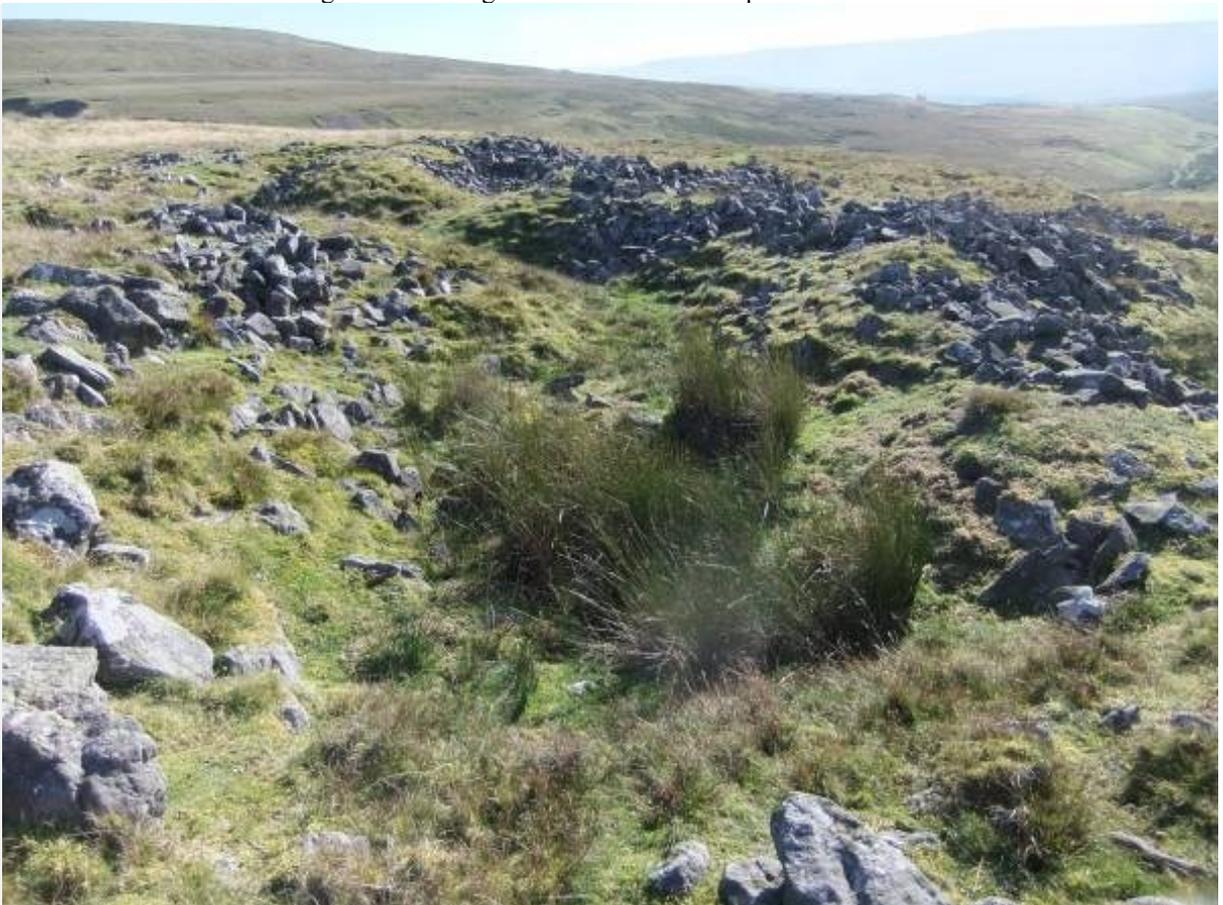
Record Number 897 >>> Image 3: The existence of structures is indicated by long passage ways leading to sunken circular areas.

Description: This unusual earthwork comprises a number of sub-circular excavations several with fragments of stone lined walling, now completely collapsed or quarried out together with interconnecting passage ways which, together are here provisionally interpreted as a clover leaf- on- plan group of sunken huts which were probably roofed with turf or heather thatch as refuges on the line of a natural high level pack horse trackway on the interfluvium above the southern edge of Teesdale or through Fagnergill to Bowes and the Stainmore Pass now the line of the A66.

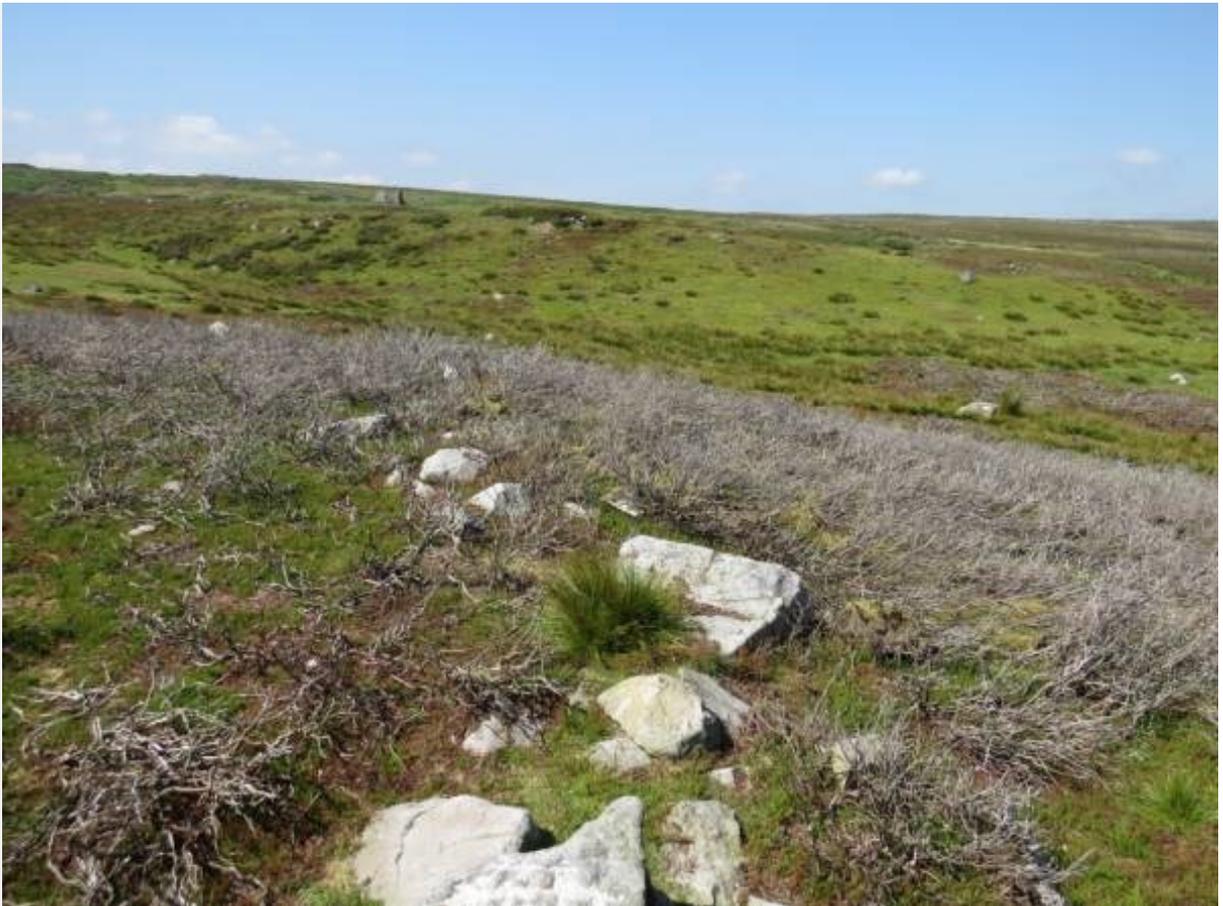
Record Number 1008 >>> Image 1: The wall debris looking north. The wall appears to be running from one ridge to the other, but its purpose is not obvious. It does not appear to link to any other wall or obstacle and only runs north/south for a reasonably short distance. The building in the distance should establish the position, should there be any difficulty finding it.

We took the right valley and found the trace of a wall. It ran between the two rising grounds, across the valleys and the promontory.

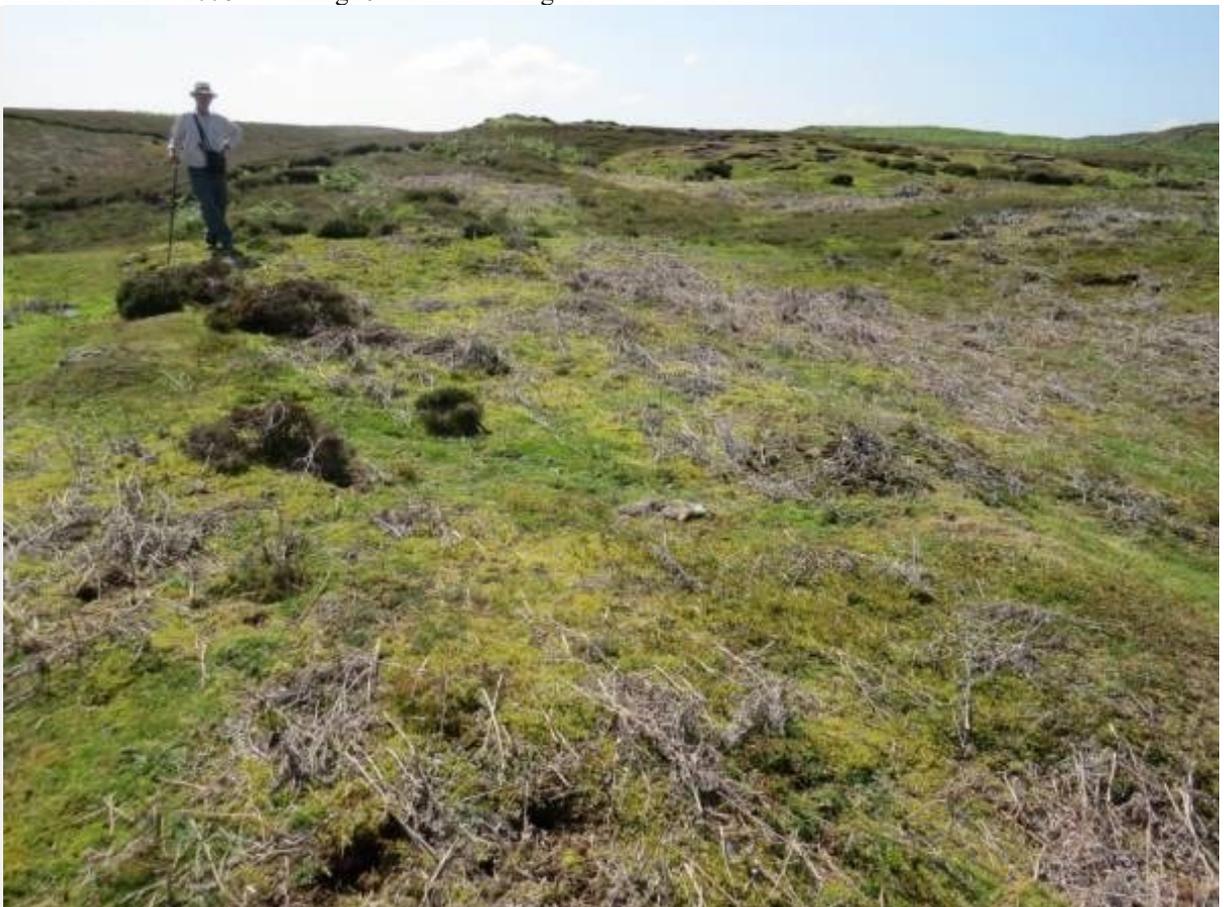
Record Number 1008 >>> Image 10: Tim standing on the sw corner of what appears to be the smithy. There was considerable appropriate waste on the slope to the left (Tim's right).

The rabbit holes on this side helped a lot as we found a lot of slag, ranging from light, lightly-burned stuff to heavy metal-coated stuff. This all came from this long slope and at the top were these stones that formed a rectangle. To the South were more substantial and a little larger remains, marked by banks. But all that slag indicated, perhaps, a blacksmiths - with a two-part building.
